Detectus AB

Pre-Scan report

File: C:\AL_AMSTR15-5.LST

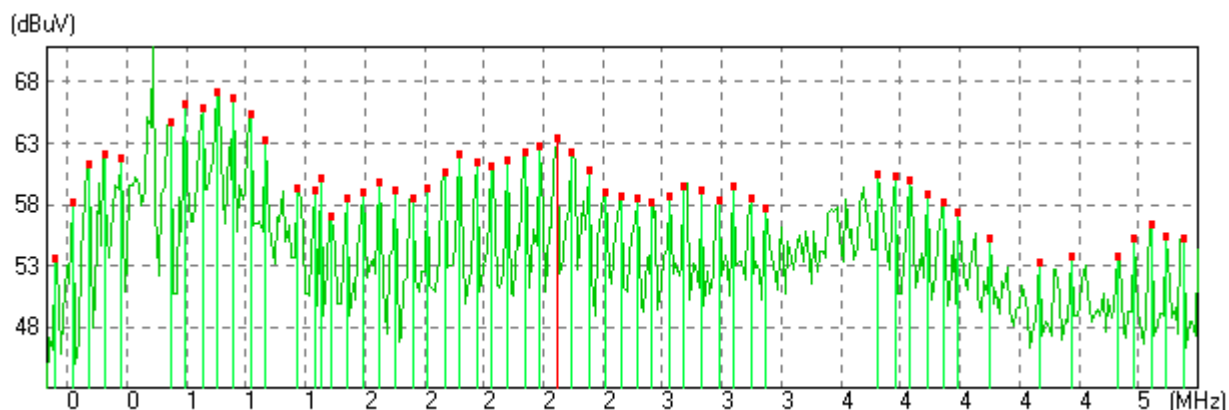
Measuring area:

X: 0mm to 220mm
Y: 0mm to 100mm
Z: 10mm
Step: 10mm in X-direction and 10mm in Y-direction.

Pre-scan resolution bandwidth: 9KZ
Setting: SET_HZ1
Probe: PROBE_HZ530M
Start frequency: 150KZ
Stop frequency: 5MZ

Peaklist:

611KZ	71.32dBuV
878KZ	67.78dBuV
950KZ	67.23dBuV
744KZ	66.68dBuV
817KZ	66.51dBuV
1.023MZ	65.97dBuV
684KZ	65.27dBuV
1.084MZ	63.82dBuV
2.308MZ	63.75dBuV
2.236MZ	63.32dBuV
2.175MZ	62.84dBuV
2.369MZ	62.83dBuV

1.896MZ	62.61dBuV
405KZ	62.56dBuV
477KZ	62.33dBuV
2.102MZ	62.25dBuV
1.969MZ	61.96dBuV
344KZ	61.76dBuV
2.029MZ	61.71dBuV
2.442MZ	61.27dBuV
1.835MZ	61.15dBuV
3.654MZ	61.14dBuV
3.727MZ	60.82dBuV
1.314MZ	60.7dBuV
3.788MZ	60.59dBuV
1.557MZ	60.36dBuV
2.842MZ	60.14dBuV
3.048MZ	60.11dBuV
1.763MZ	59.93dBuV
1.217MZ	59.89dBuV
2.915MZ	59.83dBuV
1.629MZ	59.71dBuV
1.29MZ	59.67dBuV
2.514MZ	59.61dBuV
1.496MZ	59.5dBuV
3.86MZ	59.37dBuV
2.575MZ	59.29dBuV
2.781MZ	59.19dBuV
1.423MZ	59.04dBuV
3.121MZ	58.98dBuV
1.702MZ	58.95dBuV
2.648MZ	58.95dBuV
2.987MZ	58.88dBuV
2.708MZ	58.85dBuV
3.933MZ	58.79dBuV
271KZ	58.67dBuV
3.181MZ	58.22dBuV
3.994MZ	58.01dBuV
1.363MZ	57.56dBuV
4.806MZ	56.98dBuV
4.867MZ	56.05dBuV
4.939MZ	55.85dBuV
4.733MZ	55.81dBuV
4.127MZ	55.76dBuV
4.467MZ	54.41dBuV
4.661MZ	54.27dBuV
199KZ	54.13dBuV
4.333MZ	53.93dBuV
